HUNTER'
MARINE CORPORATION
AN EMPLOYEE OWNED COMPANY

45cc Transom Ladder Support Bracket Update (11-17-07)

The following information provides the procedures for installing stainless support brackets on the transom ladder of the Hunter 45cc..

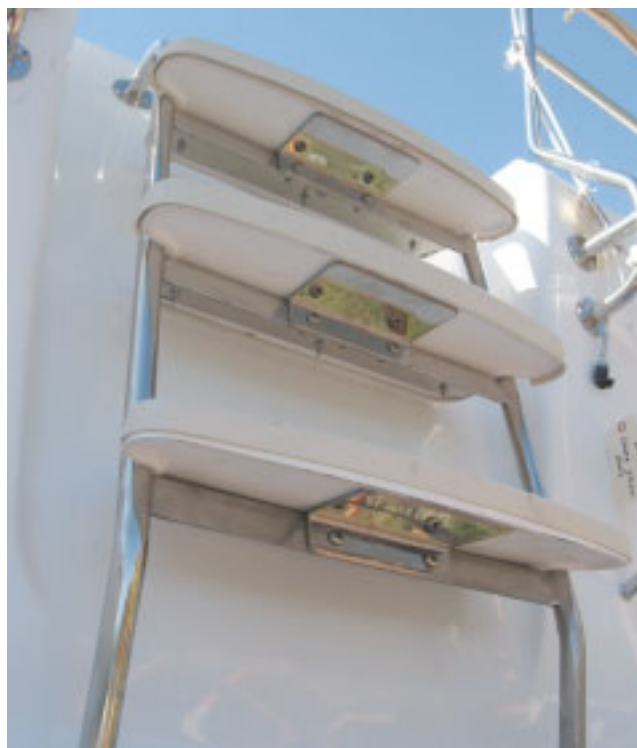
The stainless steel support bracket is to be mounted on the underside of the fiberglass step and through bolted with two 5/16" x 1/2" pan head fasteners with lock nuts to the stainless steel rail on the ladder as shown in picture below. (Please note there are **no** fasteners on the underside of the fiberglass step as it appears in the photo, this is just a reflection on the shiny surface of the bracket of the two fasteners holding the bracket to the stainless steel ladder rail.)

1. The step support bracket has two holes pre-drilled in the bracket, holding the bracket on the underside of the fiberglass step use a marker to mark location of the holes on the ladder rail, use a center punch to make a dimple in the center of the marked holes and then use an 1/8" drill bit to drill a pilot hole through the support rail followed by using an 11/32" drill bit. Install the two 5/16" x 1/2" pan heads through the support bracket and step rail and secure with 5/16" lock nuts.
